**HAZARD MAP 0.1% AEP**

Project : <b>LEE CATCHMENT FLOOD RISK ASSESSMENT AND MANAGEMENT STUDY</b>	
Map : <b>HARBOUR MODEL HAZARD MAP</b>	
Map Type :	HAZARD
Return Period :	0.1% AEP EVENT
Source :	TIDAL FLOODING
Map area :	RURAL AREA
Scenario :	CURRENT
Figure By :	Valeria Medina
Date :	19 May 2012
Checked By :	Paul Dunne
Date :	19 May 2012
Approved By :	Clare Dewar
Date :	19 May 2012
Figure No. :	M9/RA/HAZ/1000/001
Revision	1
Drawing Scale :	1:25,000
Plot Scale :	1:1 @ A3

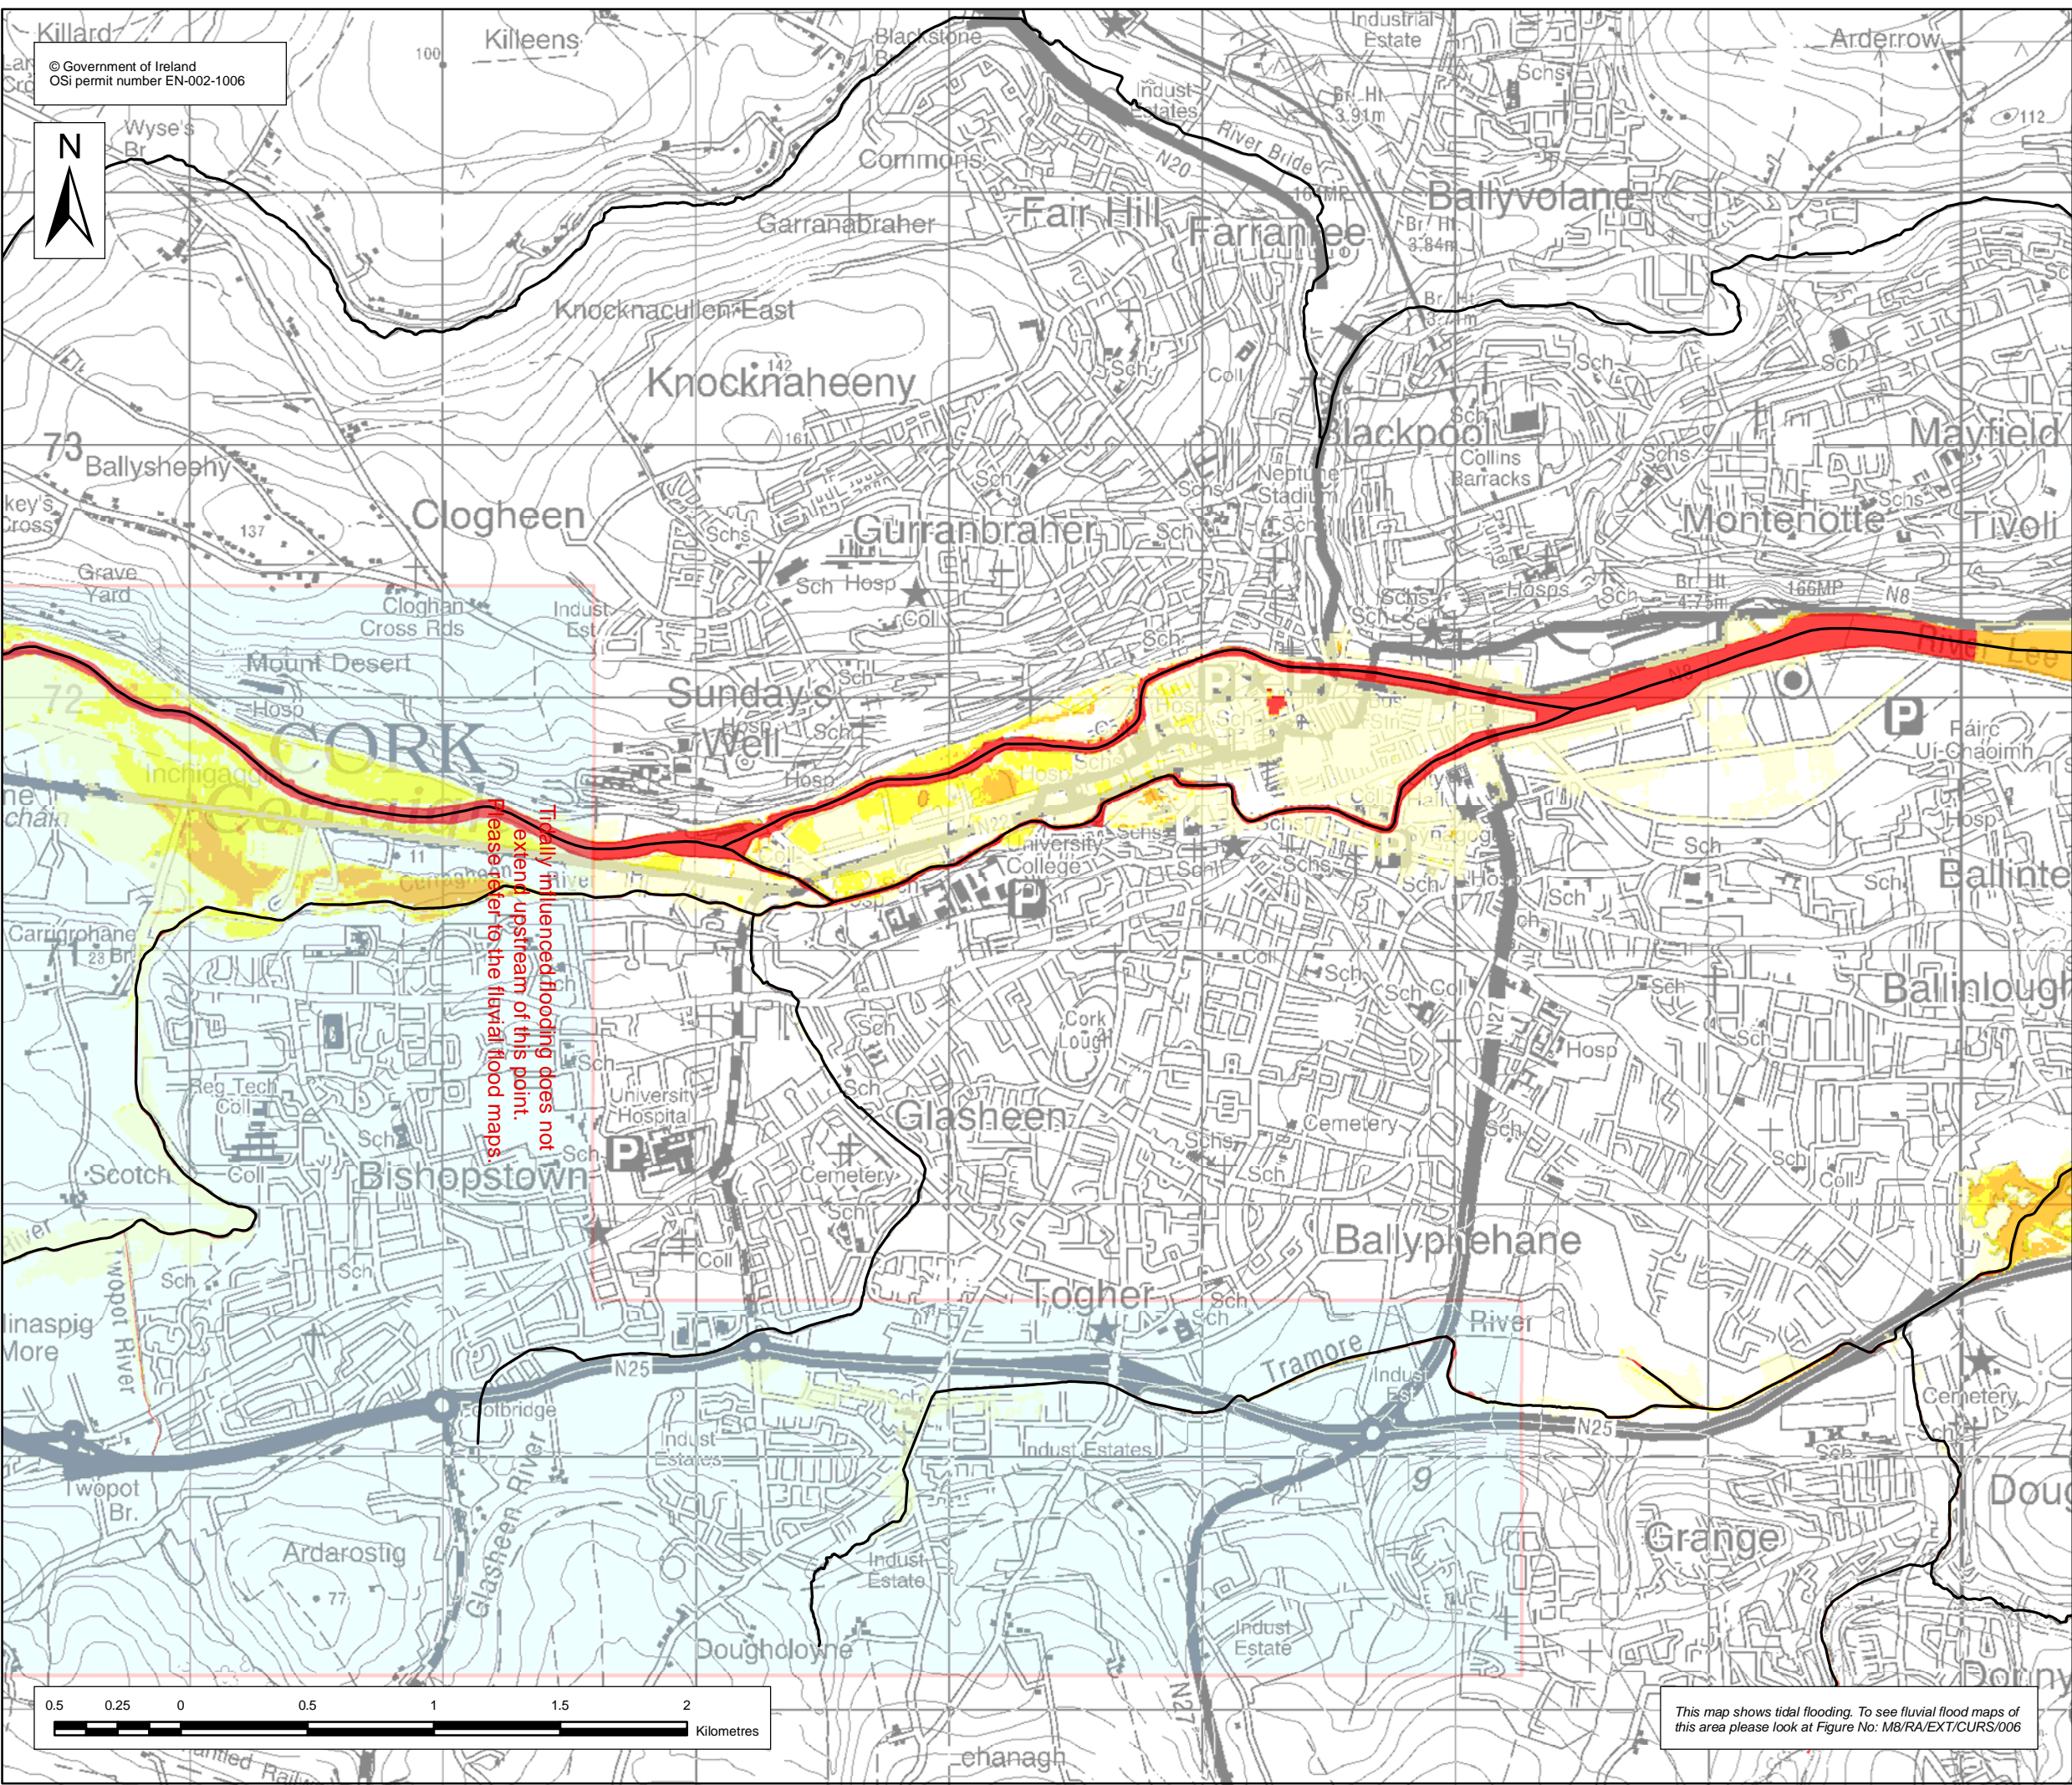
Tidally influenced flooding does not extend upstream of this point. Please refer to the fluvial flood maps.

This map shows tidal flooding. To see fluvial flood maps of this area please look at Figure No: M8/RA/EXT/CURS/006
