**HAZARD MAP 10% AEP**

Project : <b>LEE CATCHMENT FLOOD RISK ASSESSMENT AND MANAGEMENT STUDY</b>	
Map : <b>HARBOUR MODEL HAZARD MAP</b>	
Map Type :	HAZARD
Return Period :	10% AEP EVENT
Source :	TIDAL FLOODING
Map area :	RURAL AREA
Scenario :	CURRENT
Figure By :	Valeria Medina
Date :	19 January 2010
Checked By :	Juan Fernandez
Date :	19 January 2010
Approved By :	Jenny Pickles
Date :	19 January 2010
Figure No. :	M9/RA/HAZ/10/005
Revision :	0
Drawing Scale :	1:25,000
Plot Scale :	1:1 @ A3

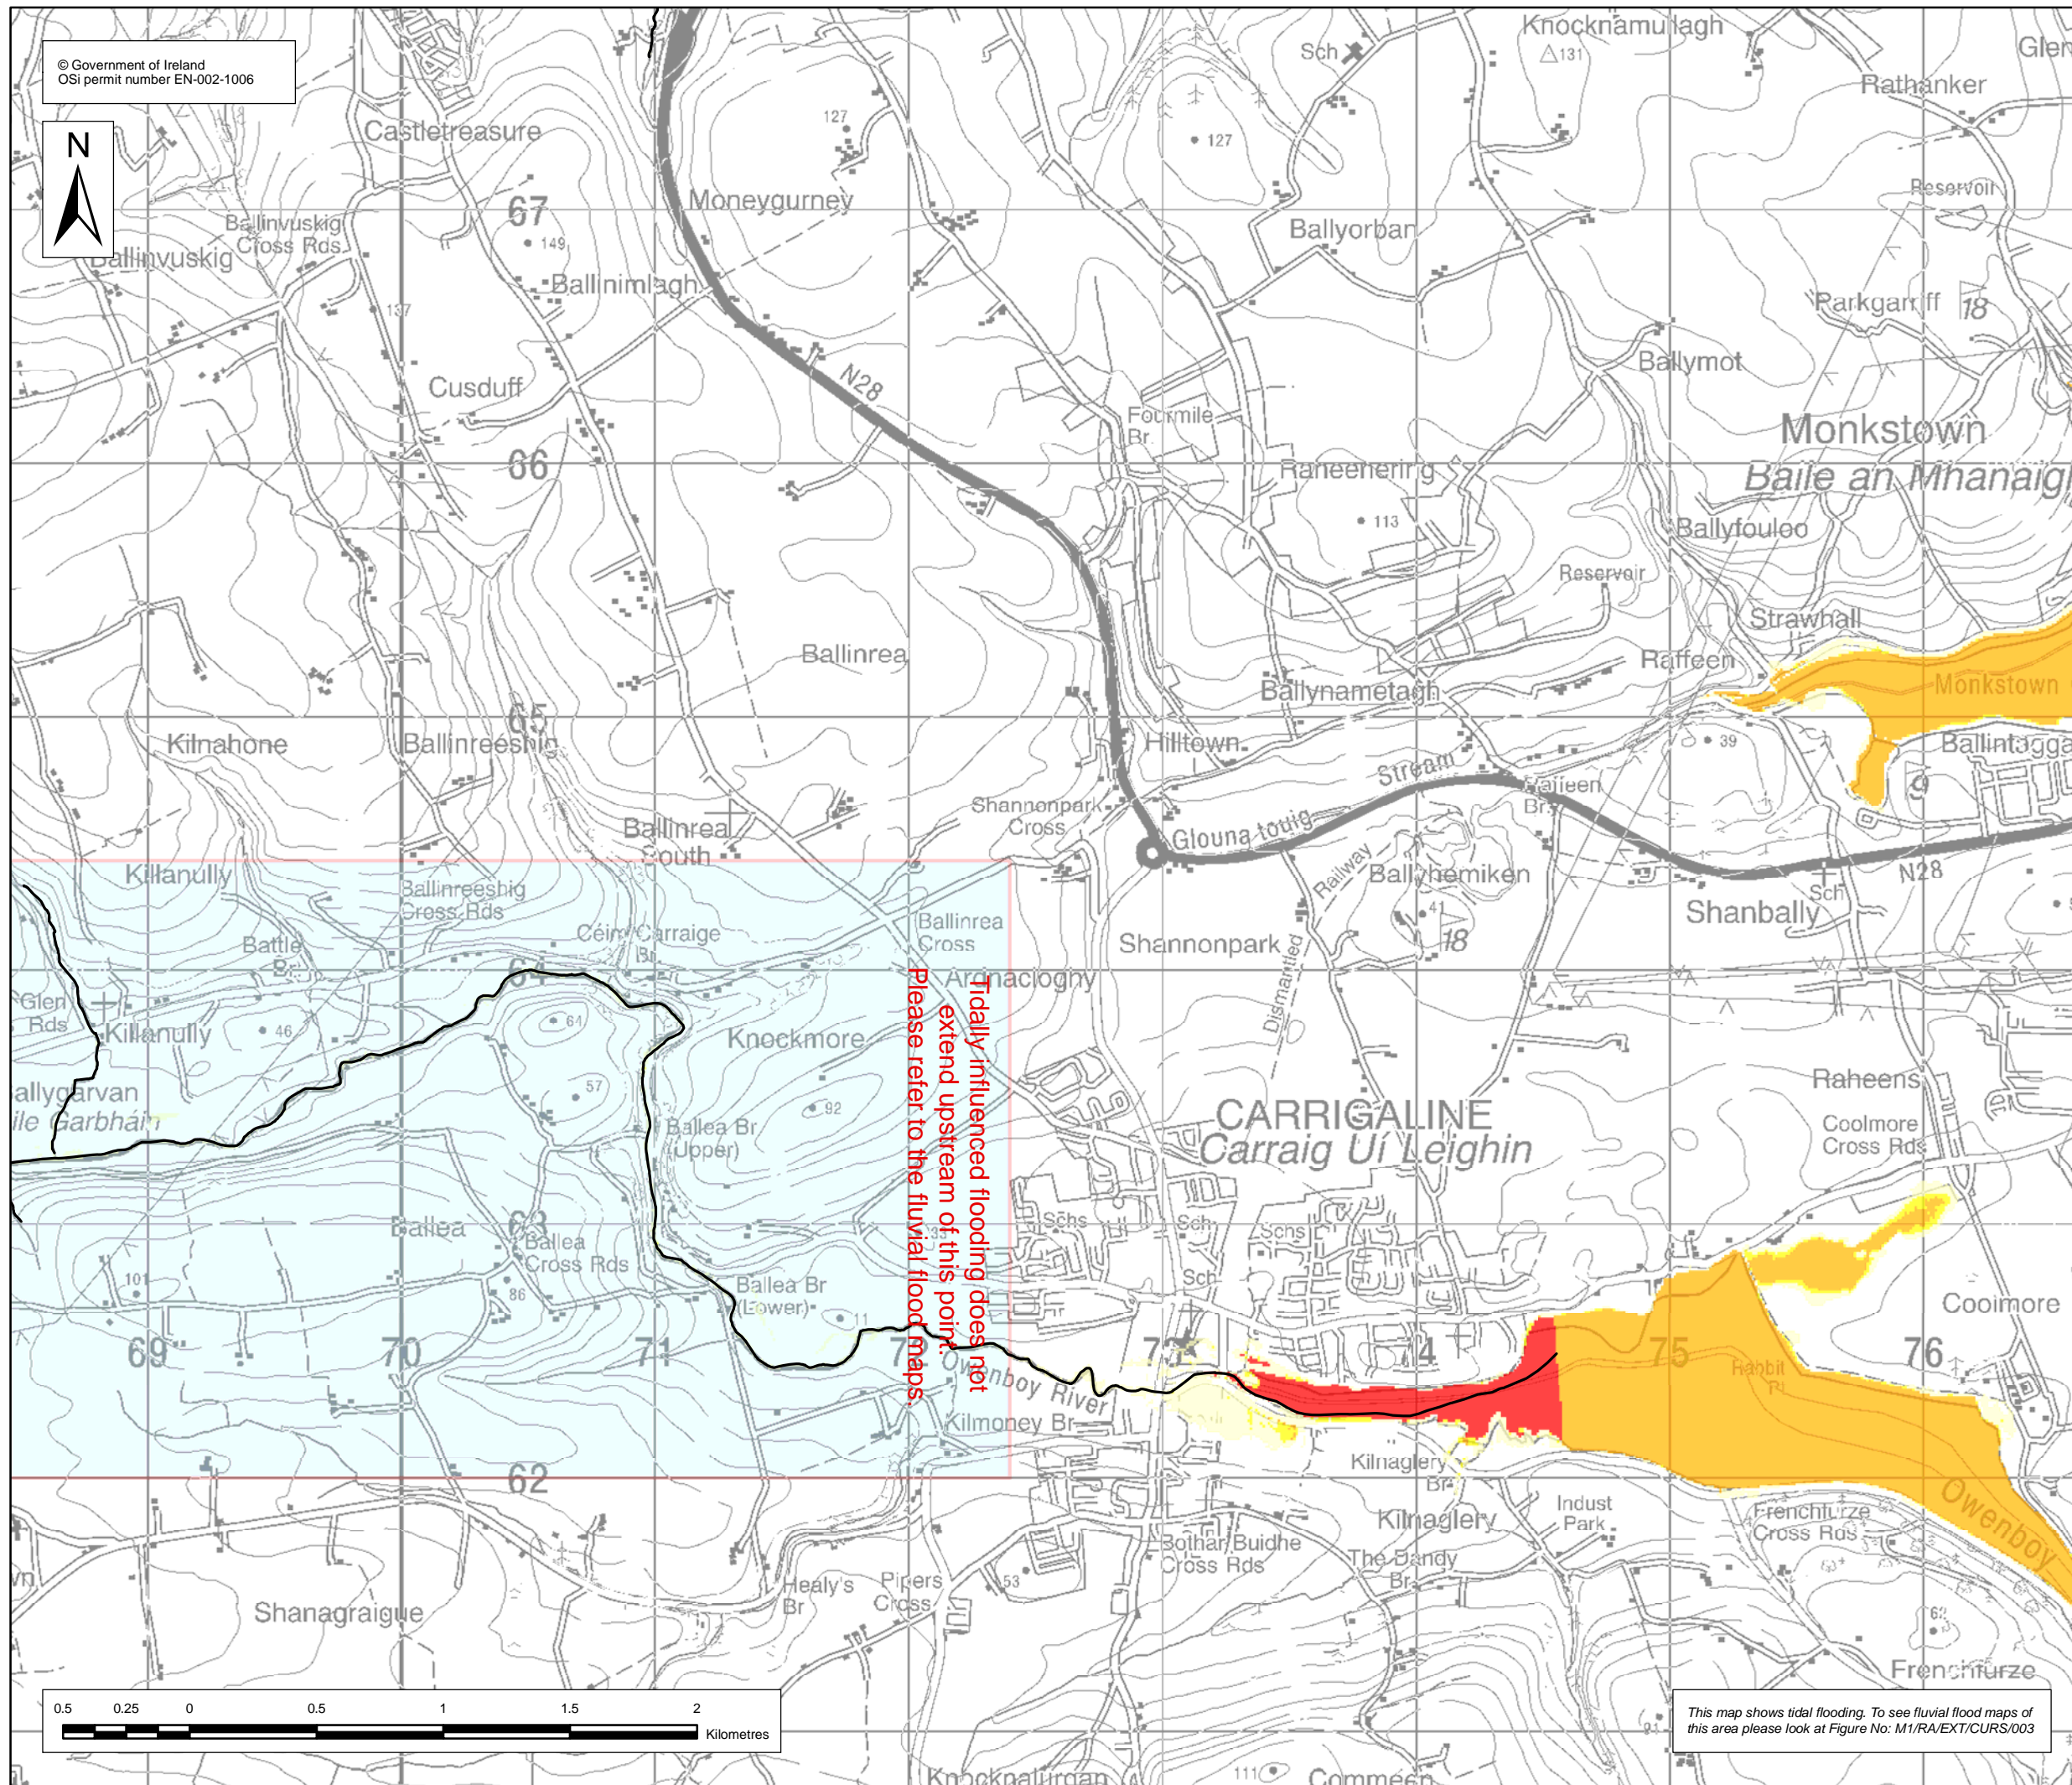
Tidally influenced flooding does not extend upstream of this point. Please refer to the fluvial flood maps.

This map shows tidal flooding. To see fluvial flood maps of this area please look at Figure No: M1/RA/EXT/CURS/003
